UNITED STATES ENVIRONMENTAL PROTECTION AGENCY

Re: MS4 Inspection - Village of Lloyd Harbor
NPDES Permit No. NYR20A299

MS4 Inspection Report/Village of Lloyd Harbor NY (NYR20A299)
September 16-17, 2013

PHOTOGRAPH LOG (Panasonic Lumix L8Z)

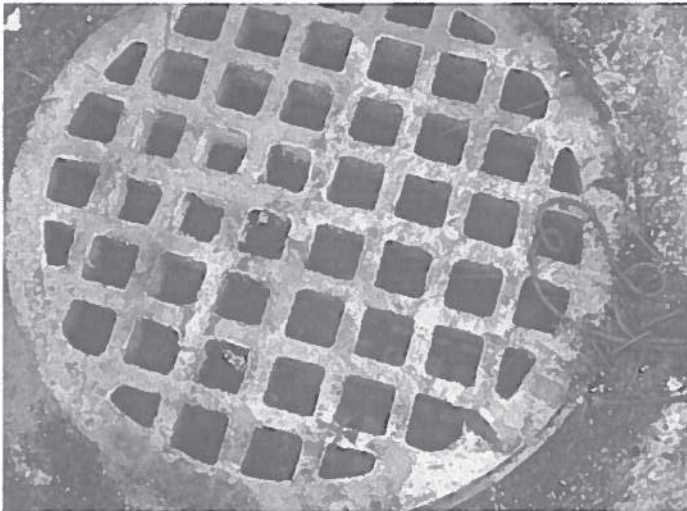
Truck wash-down dry well onsite at Village Garage receiving paint residues

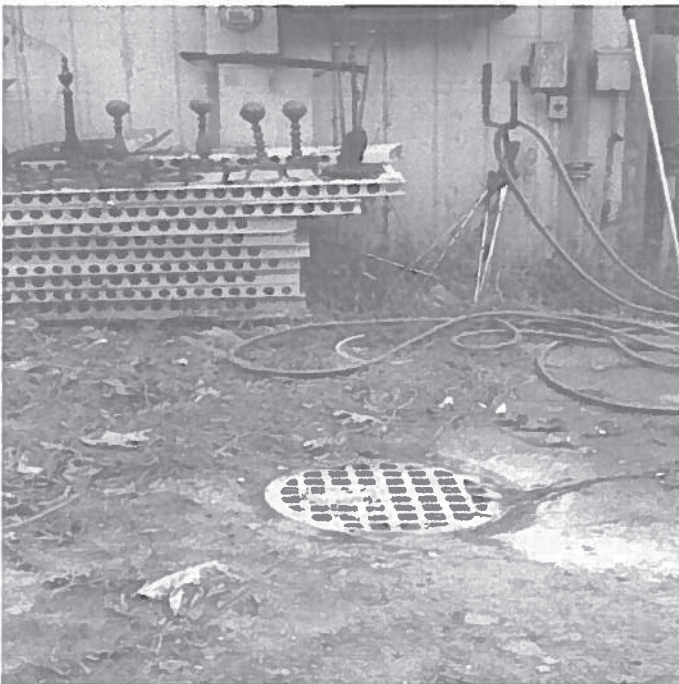
Truck wash-down dry well onsite at Village Garage receiving paint residues
